FOURTH QUARTERLY PROGRESS REPORT

Period Covered: January 1, 1979 - March 31, 1979

DEVELOP SILICONE ENCAPSULATION
SYSTEMS FOR TERRESTRIAL SILICON
SOLAR ARRAYS

JPL Contract 954995

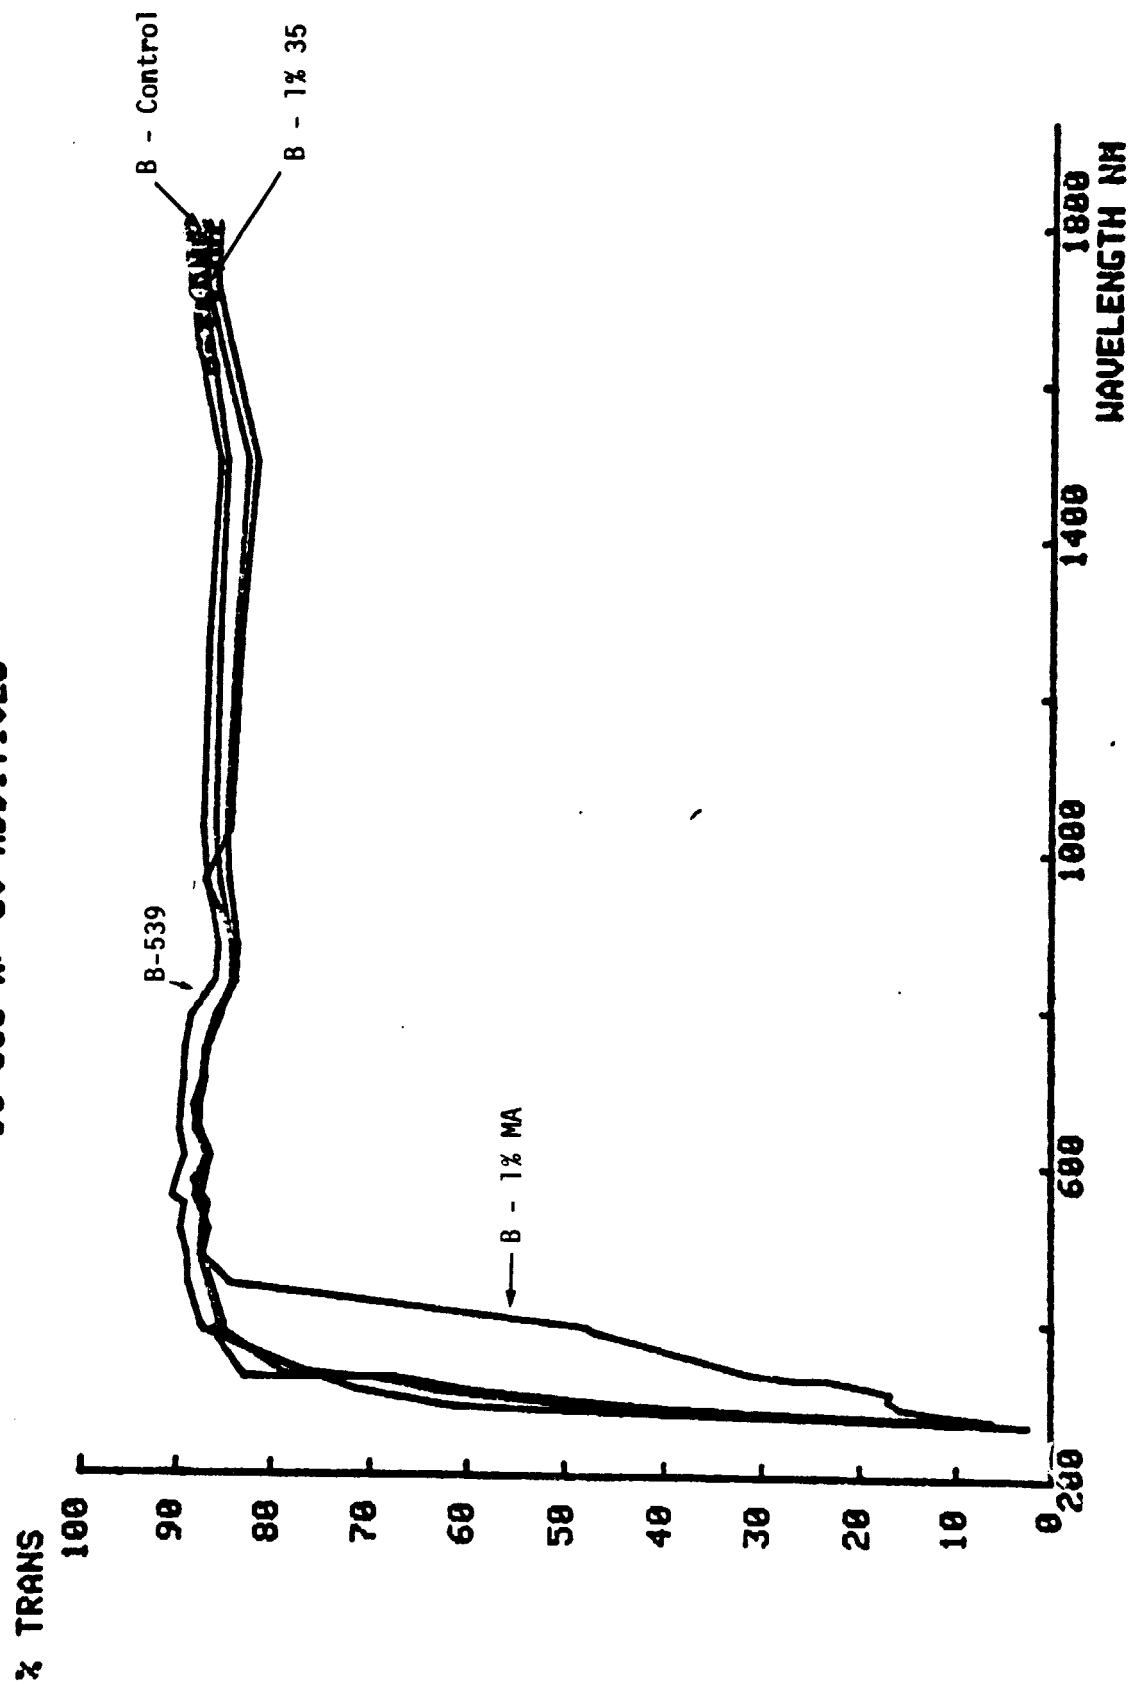
FIGURE 12
DC 808 W/ UV ADDITIVES

The transmittances of the cured films with and without UV absorbing agents were measured and normalized to 1 mil thicknesses. These results are shown in Figures 7-12.

The DC® 808 films containing Uvinul N-35 and N-539 are not much different than the control. These films of DC® 808 were cured at 100°C for two hours which probably caused the relatively low molecular weight UV absorbing compounds to vaporize.
